PAD A MAIN FLAME DEFLECTOR SENSOR DATA AND EVALUATION

Christopher R. Parlier

NASA, Kennedy Space Center, FL 32899, U.S.A.

Thermal & Fluids Analysis Workshop
TFAWS 2011
August 15-19, 2011
NASA Langley Research Center
Newport News, VA

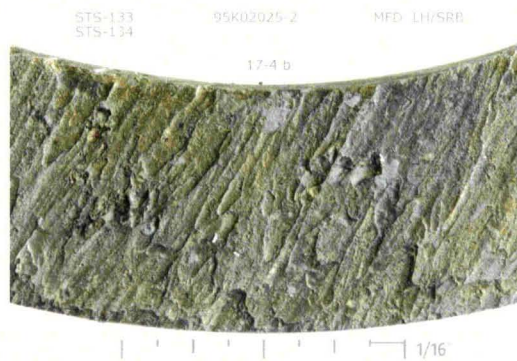
Figure 8. Top A-286 Sleeve Post Launch.

In order to protect the sides of the tungsten calorimeter a A-286 sleeve was incorporated in the design. Figure 9 shows the top and isometric views of this piece. The tungsten calorimeter utilized an outer 17-4 housing to shield the tungsten calorimeter. The image is a micrograph of the 17-4 housing which was rotated 90° after STS-133 and reused for STS-134. At the time of this manuscript submittal the metallography and thermal response modeling data had not been completed.

- Metallography is in work
- Thermal analysis is in work

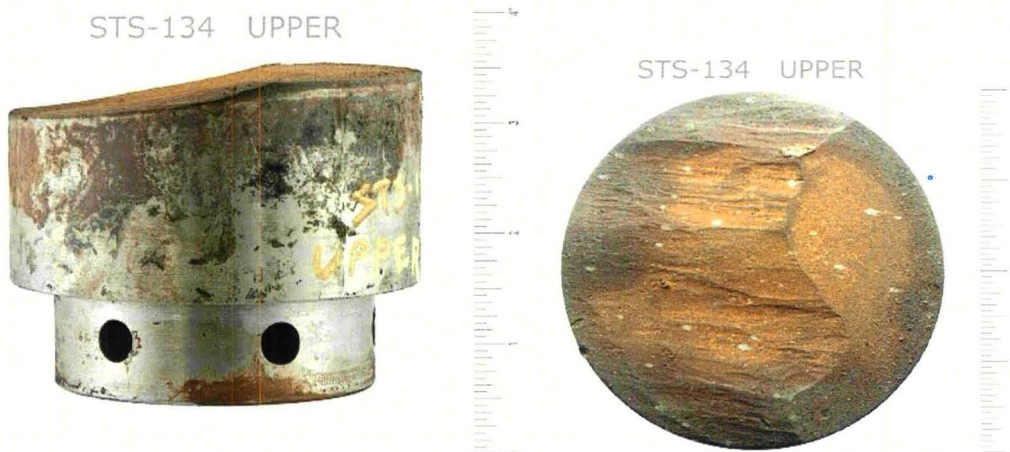
Figure 14. STS-134 1018 Top Witness Rod.

After the launch of STS-134 the material for the witness rod was changed to AISI 1018, based on the usage of the material in the solid rocket booster separation motors (BSM). These BSMs have a similar loading environment to data collected from STS-133. The material eroded 0.4 inches. The metallography and thermal analysis was not complete at the time of submission.

- Metallography is in work
- Thermal analysis is in work
- Erosion on the order of 0.4" occurred
- Material selected because of its use in BSM (booster separation motor) nozzles

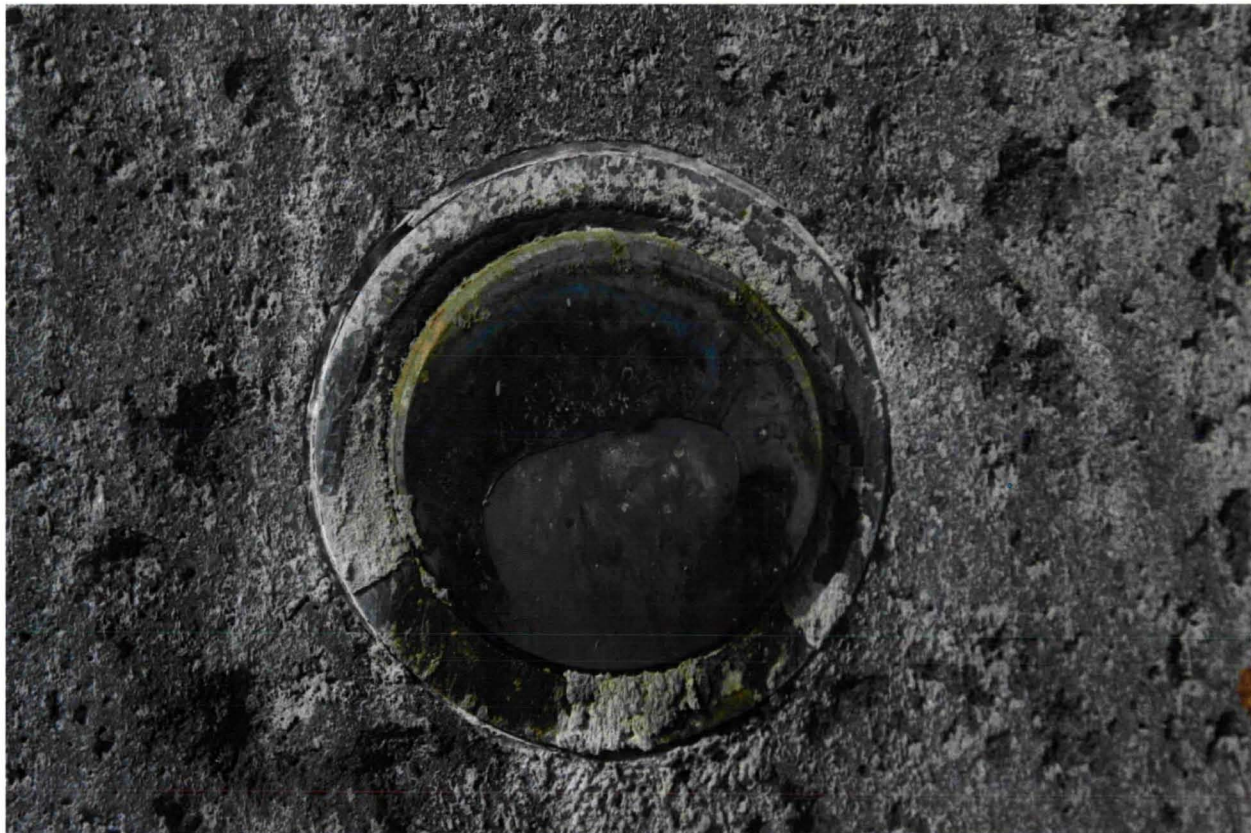
STS-135 Top Tungsten Calorimeter

- Removal from the pad scheduled 7/21/11
- Metallography TBD
- Thermal analysis TBD
- Erosion TBD
